Place tyres. An experience we rather do not see.

(From Zwerfauto No. 141, the Netherlands)

English translation from Dutch

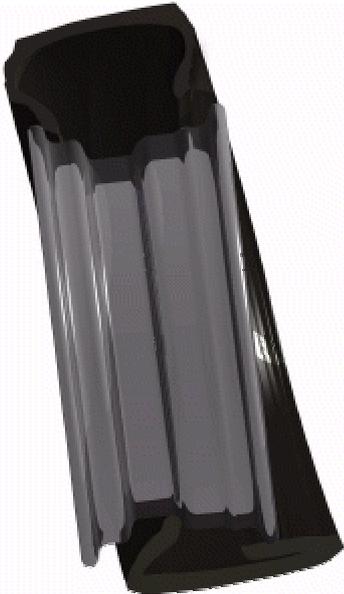
Illustration 1: State of empty tyres

In the normal driving company the atmospheric pressure provides in the tyre that connects the edges of the tyre exactly against the rim. If the atmospheric pressure escapes during drive, these edges are pressed in the middle by the rim where the diameter is smaller. The small diameter is required to mount the tyre. The wheel in illustration 1 (at the end of this report) allows to see what passed if the tyre comes to this hollow cavity.

This has different negative results;

- 1) The tyre "flutters" under the rim by which this starts to fling.
- 2) The tyre can completely run from the rim.
- 3) The rim falls on the street and damages.

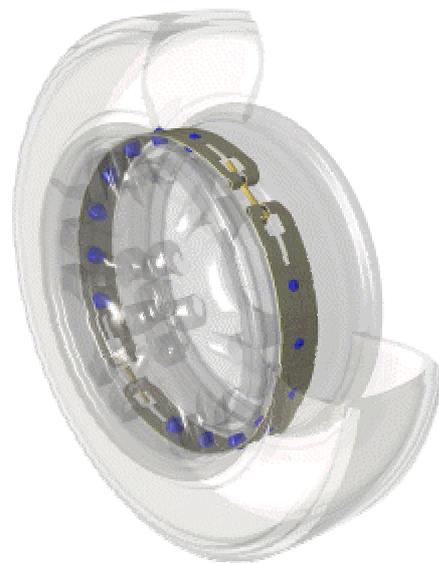
Illustration 2: Seat belt in rim

The system is quite easy: a stripe in the assembly space and hollow cavity holds the tyre on his place, also sees illustration 2. This is of the new generation stripes of Tyron.

The stripe lies close not against the rim, but on a rise with plastic connection, through this Tyron can exactly tune the height and forbears to the rim, to the avoidance from rust education.

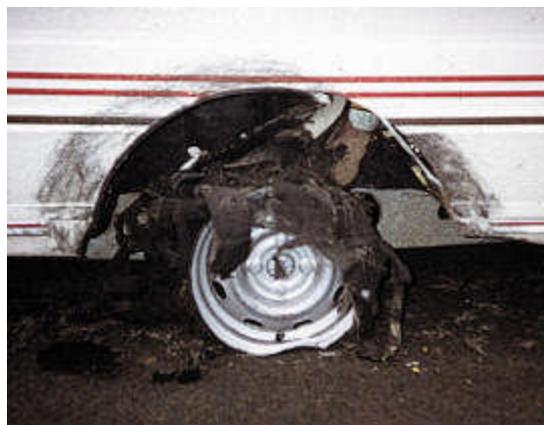
Illustration 3: damaged bicycle box by a place tyre

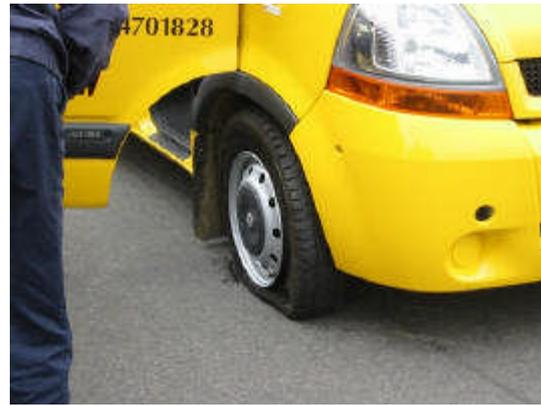
Illustration 5: In spite of maturity teaches one was able wide driving.
